## Termite, Pest, & Rodent Evaluation Report

**DATE:** Jul 17, 2019  
**CLIENT LAST NAME:** Sample  
**ADDRESS (street):** 123 Sample St.  
**CLIENT EMAIL:** rob@pestnation.com  
**AGENT EMAIL:** rob@pestnation.com  
**PEST INSPECTOR:** Jason Smith  
**IMAGE OF STRUCTURE:**

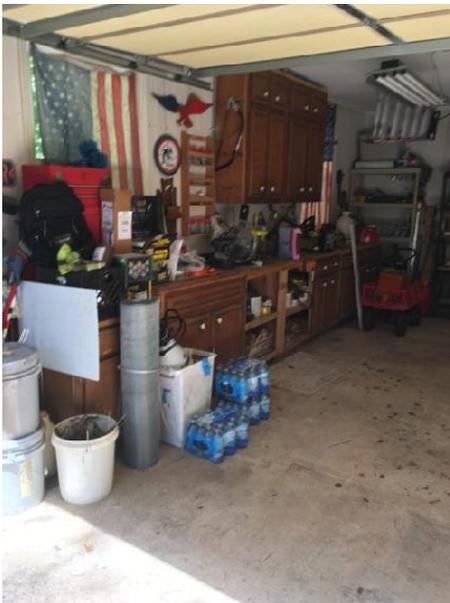
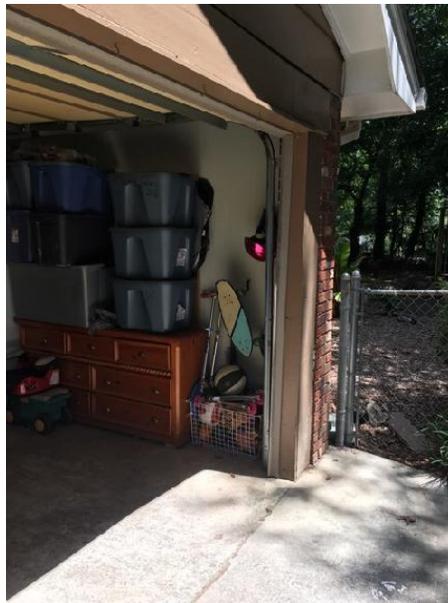
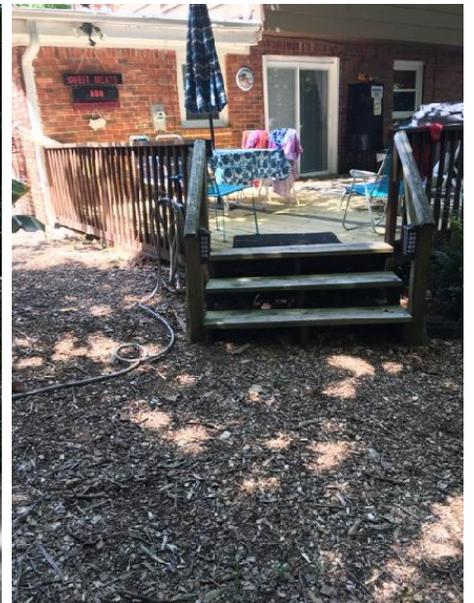
Pics 1-3 stored items in garage prevent a full inspection. Possible hidden infestation and or damage.

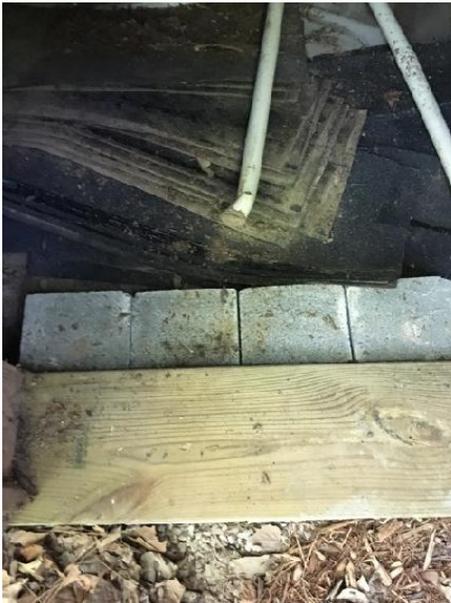
Pic 4 wood to ground contact at decking components.

This includes wood to ground contact, inadequate framing clearances in crawl spaces, cellulose debris in crawl spaces, inadequate ventilation in crawl spaces, and moisture issues. It is recommended that as many conducive conditions as possible be eliminated.

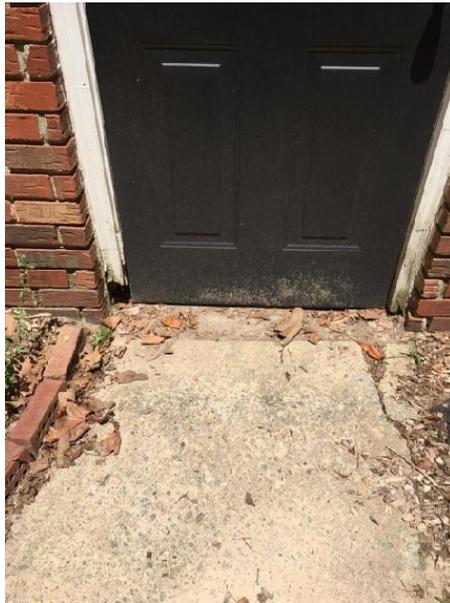
Pic 5 framing clearance at crawl door frame in crawl space less than 18" from soil.

Pic 6 moisture issues in door trim

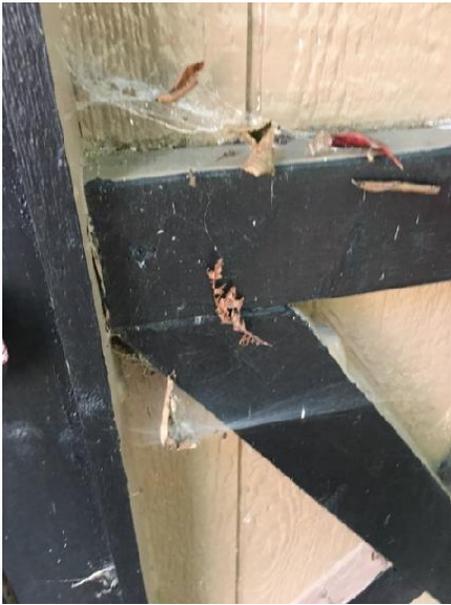
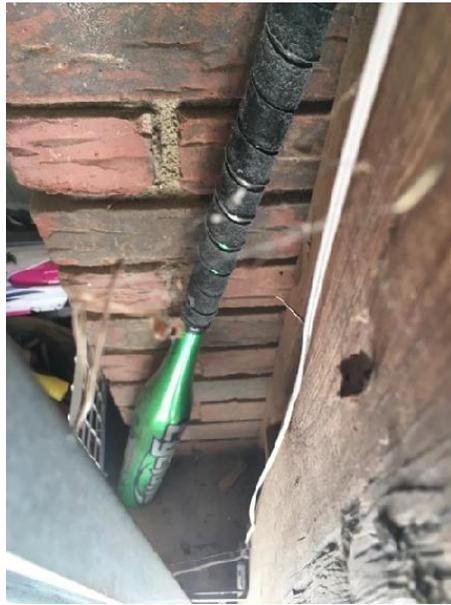
<b>GENERAL PEST FINDINGS:</b>	General Crawling Pests
<b>LOCATION OF PEST FINDINGS:</b>	Exterior
<b>IMAGES:</b>

Spiders

Yes, Georgia's climate is conducive to pest issues

Every 3 Months

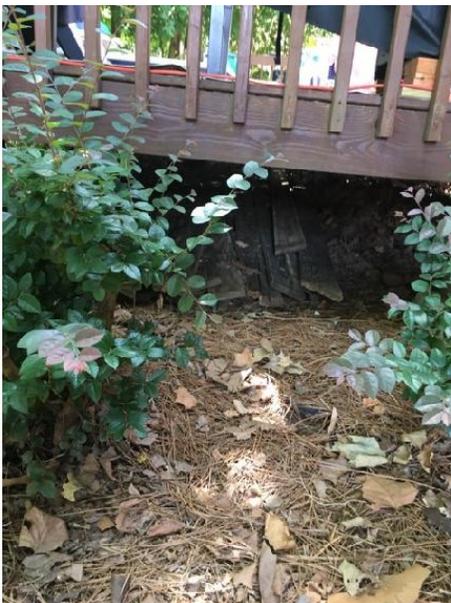
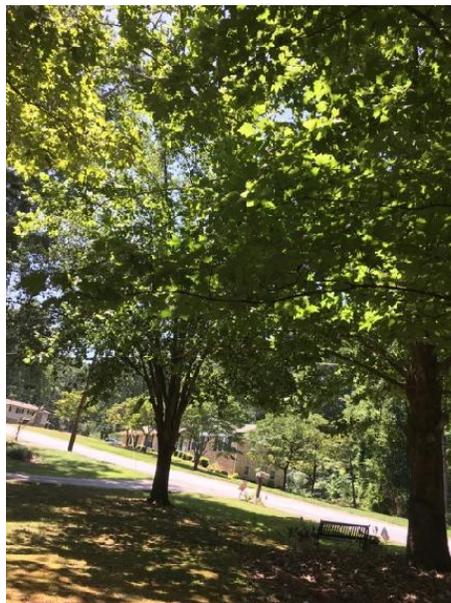
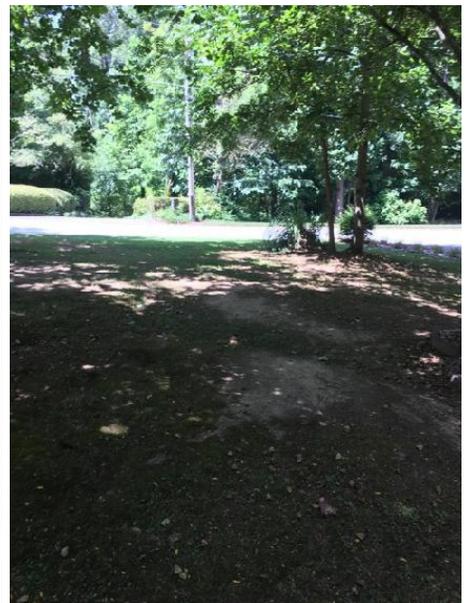
Breeding Sites  
Heavy Vegetation  
Damp Areas  
Conducive Conditions on Property  
Conducive Conditions on Neighboring Property  
Mosquito Activity During Inspection

<b>IMAGE COMMENTS:</b>	Harboring sites found
<b>MOSQUITO PREVENTION RECOMMENDED:</b>	Yes, Georgia's climate is conducive to mosquito issues
<b>PESTNATION'S MOSQUITOGUARD INITIAL SERVICE FEE:</b>	\$0.00
<b>ONGOING PER SERVICE FEE:</b>	\$0.00
<b>SERVICE FREQUENCY:</b>	Monthly March - October
<b>MOSQUITO TREATMENT ZONE:</b>	100ft radius around structure

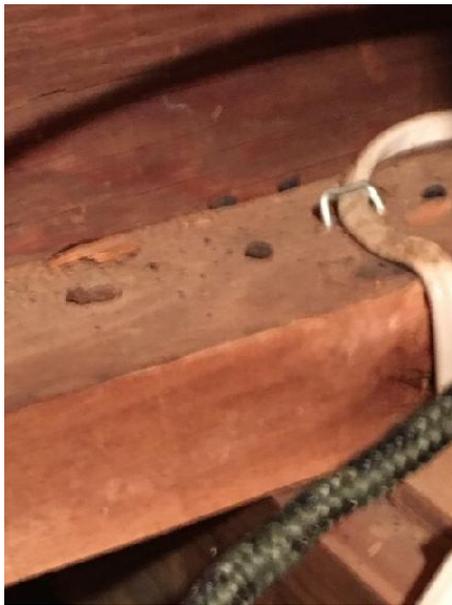
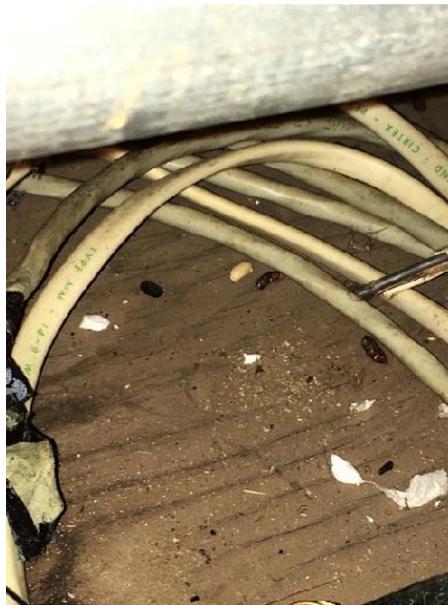
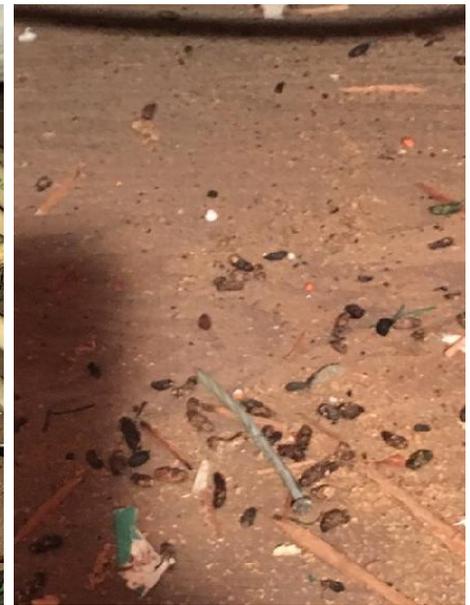
<b>EVIDENCE REVEALED:</b>	Activity or Previous Activity Observed Droppings in Attic
<b>SPECIES SUSPECTED:</b>	Rats
<b>EVIDENCE LOCATED AT:</b>	Attic
<b>ENTRY POINTS OBSERVED:</b>	Gaps at Roof Perimeter
<b>IMAGES:</b>

**COMMENTS:** Droppings in attic space over garage

A full exclusion process is the only true way to permanently solve a rodent entry problem. A full exclusion will seal all possible entry points in the structure from the roof to the ground. All other rodent solutions will be temporary in nature because entry points to the structure will still exist. With full exclusion, the rodents will have no possible entry point to the structure and all current rodents inside of the structure will be trapped/removed.
