Termite, Pest, & Rodent Evaluation Report

DATE: Jul 17, 2021
CLIENT LAST NAME: Sample
ADDRESS (street): 123 Sample St.
CLIENT EMAIL: sample@gmail.com
AGENT EMAIL: sample@gmail.com
PEST INSPECTOR: Eric Jennings
IMAGE OF STRUCTURE:

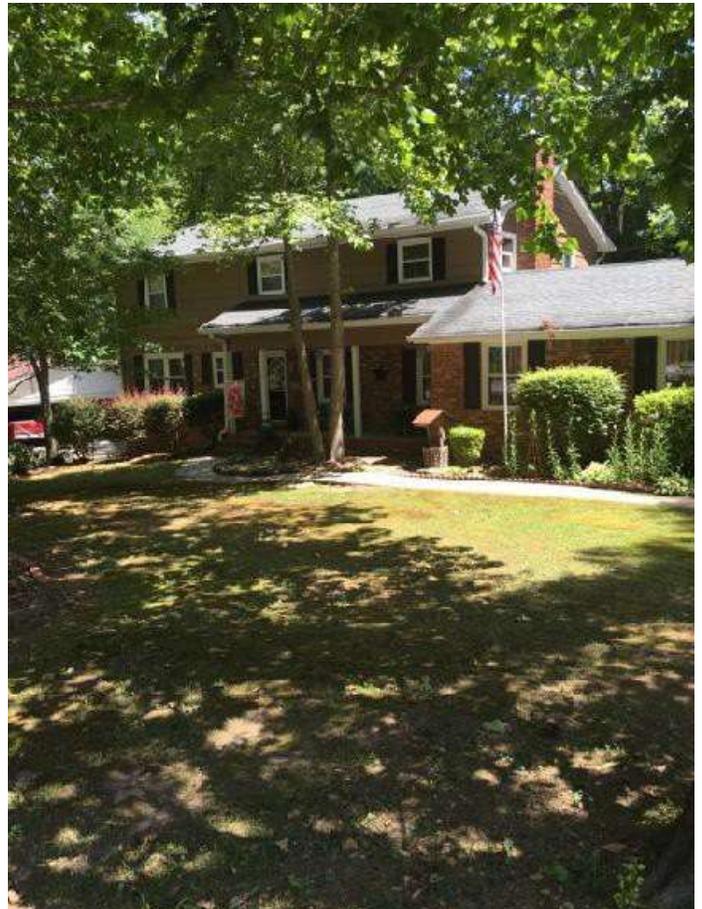
STRUCTURE TYPE:	Single Family Crawl
TERMITE INSPECTION FINDINGS:	No Activity
LOCATION OF TERMITE FINDINGS:	N/A
COMMENTS:	Cannot inspect behind fixed ceiling, flooring, wall coverings, insulation, appliances etc. Possible hidden infestation and or damage.
DRYWOOD TERMITES:	None
POWDER POST BEETLES:	None
WOOD BORING BEETLES:	None
WOOD DECAYING FUNGUS (not molds and mildews):	None
CONDUCTIVE CONDITIONS:	Wood to Ground Contact Inadequate Crawl Space Ventilation Debris in Crawl Space Inadequate Framing Clearance in Crawl Space Moisture Issues
OBSTRUCTED OR INACCESSIBLE AREAS:	Stored Items in Garage Prevented Full Inspection

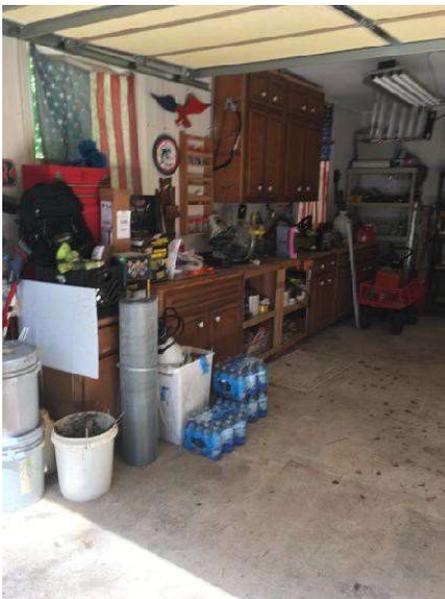
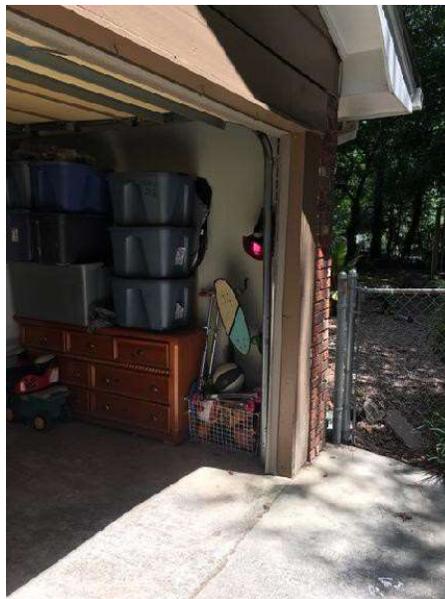
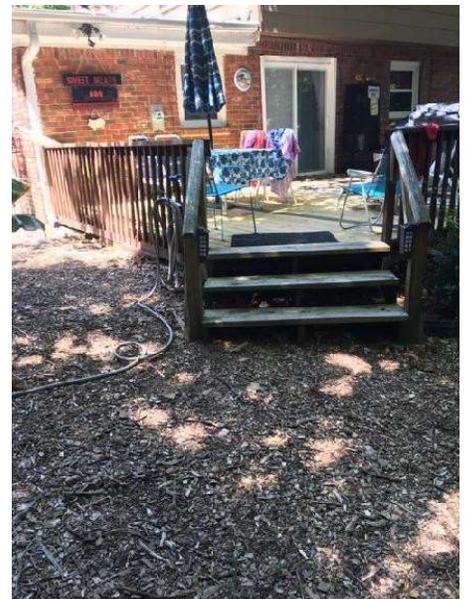
Pics 1-3 stored items in garage prevent a full inspection. Possible hidden infestation and or damage.

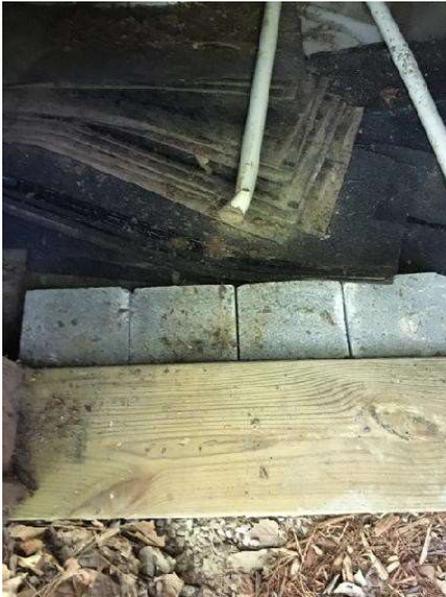
Pic 4 wood to ground contact at decking components.

This includes wood to ground contact, inadequate framing clearances in crawl spaces, cellulose debris in crawl spaces, inadequate ventilation in crawl spaces, and moisture issues. It is recommended that as many conducive conditions as possible be eliminated.

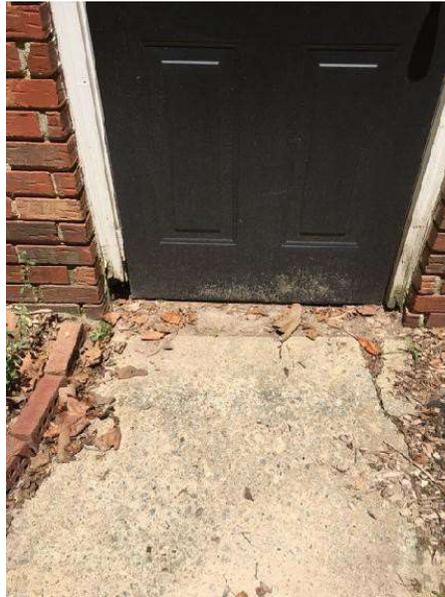
Pic 5 framing clearance at crawl door frame in crawl space less than 18" from soil.

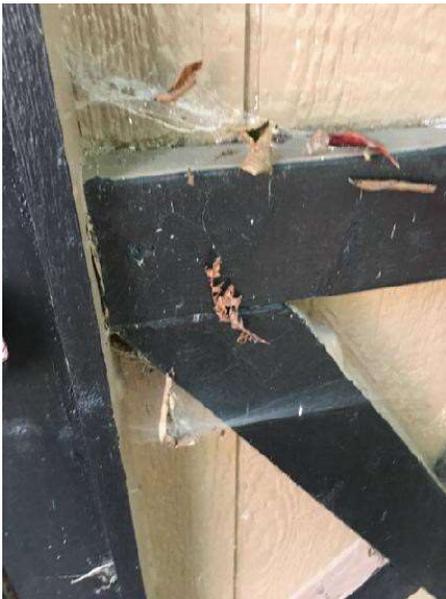
Pic 6 moisture issues in door trim

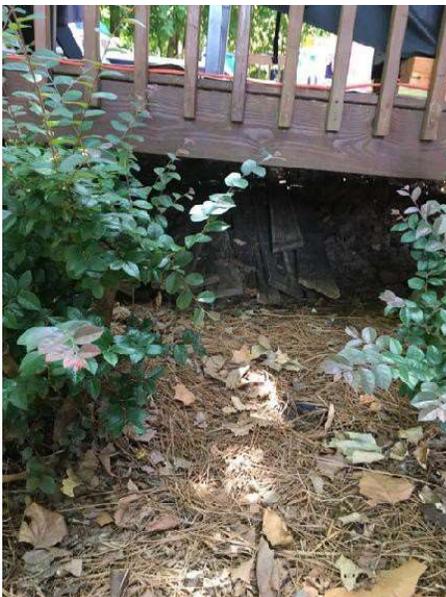
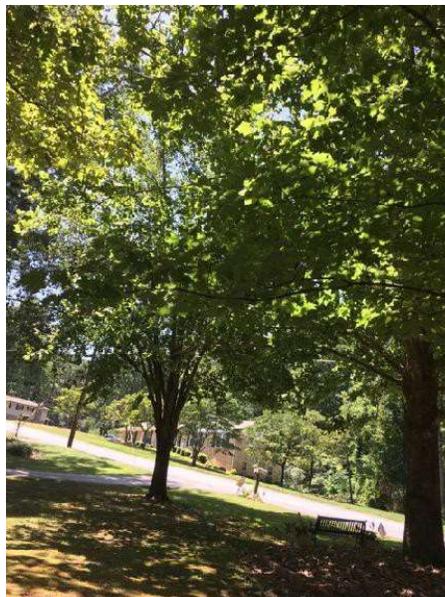
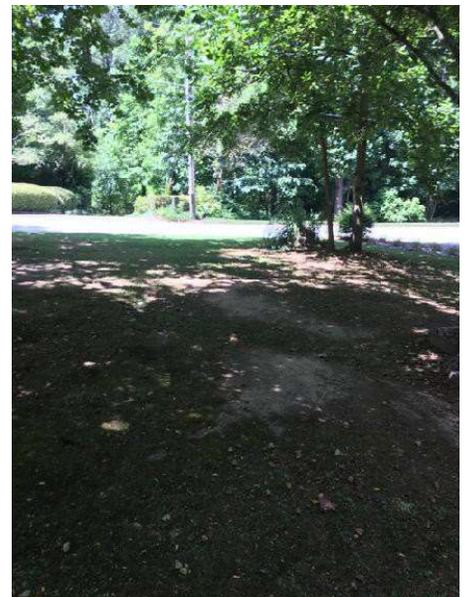
- Breeding Sites
- Heavy Vegetation
- Damp Areas
- Conducive Conditions on Property
- Conducive Conditions on Neighboring Property
- Mosquito Activity During Inspection

IMAGE COMMENTS:	Harboring sites found
MOSQUITO PREVENTION RECOMMENDED:	Yes, SC's climate is conducive to mosquito issues
PESTNATION'S MOSQUITOGUARD INITIAL SERVICE FEE:	\$0.00
ONGOING PER SERVICE FEE:	\$0.00
SERVICE FREQUENCY:	Monthly March - October
MOSQUITO TREATMENT ZONE:	100ft radius around structure

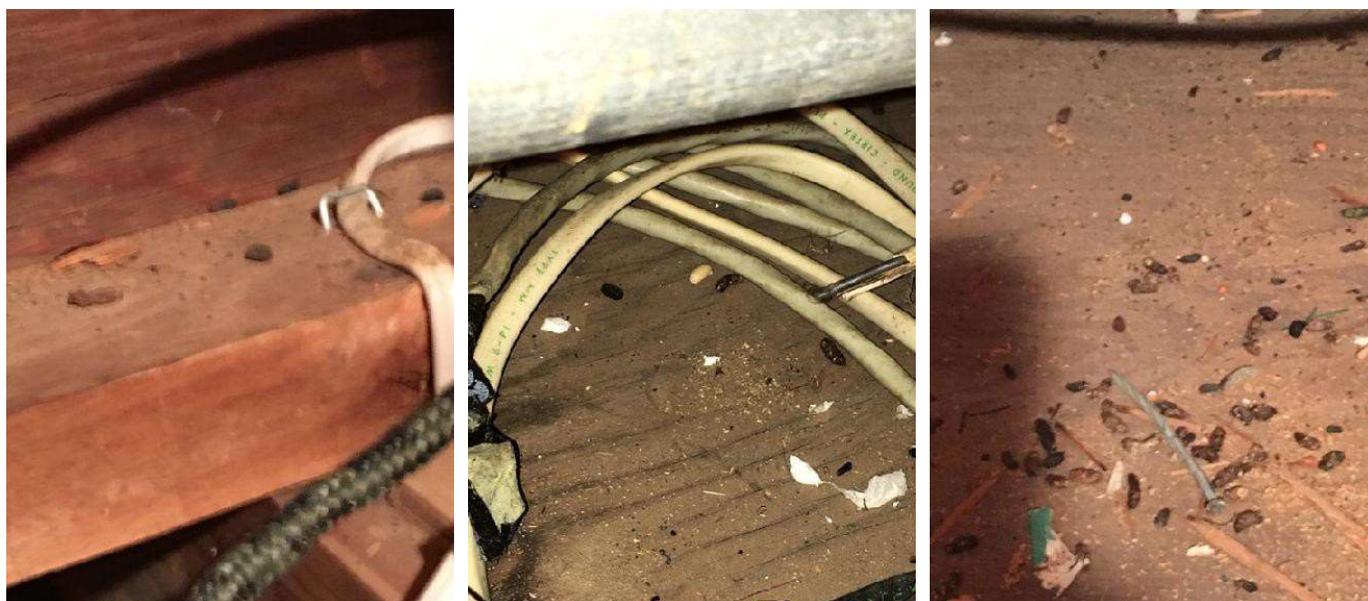
EVIDENCE REVEALED:	Activity or Previous Activity Observed Droppings in Attic
SPECIES SUSPECTED:	Rats
EVIDENCE LOCATED AT:	Attic
ENTRY POINTS OBSERVED:	Gaps at Roof Perimeter

COMMENTS: Dropping's in attic space over garage

A full exclusion process is the only true way to permanently solve a rodent entry problem. A full exclusion will seal all possible entry points in the structure from the roof to the ground. All other rodent solutions will be temporary in nature because entry points to the structure will still exist. With full exclusion, the rodents will have no possible entry point to the structure and all current rodents inside of the structure will be trapped/removed.
